# Manhole Inspection Summary

Manhole # S33I\_\_026MH

Insp Date: **9/22/08 12:17 PM**

**Location** Address: **100 hanover st**

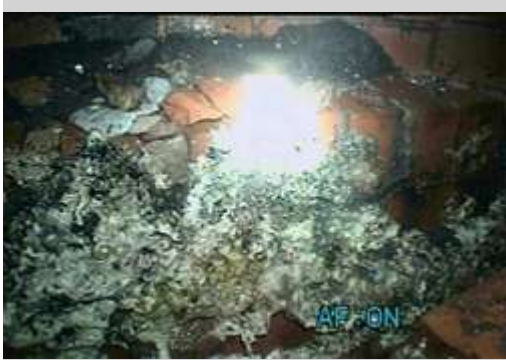
Defect 3

Condition: ☐ Sound ☐ Cracked ☐ Root Intrusion ☐ Deteriorated ☐ Leaks ☒ **Debris**

bench debris

channel debris

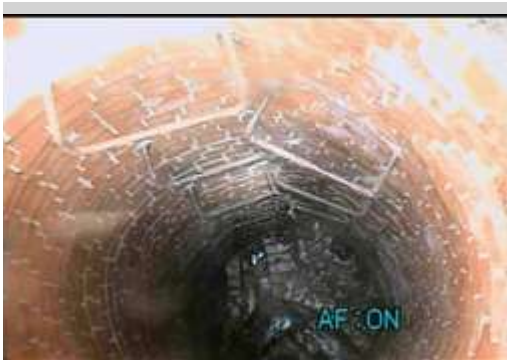
Defect 2

Count: **9** Missing: **0** ☒ **Corroded**

corroded steps

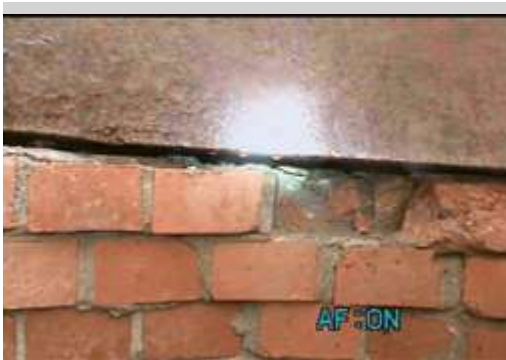
Defect 1

Condition: ☐ Sound ☐ Cracked ☐ Root Intrusion ☒ **Loose Brick** ☐ Deteriorated

chimney cond loose bricks

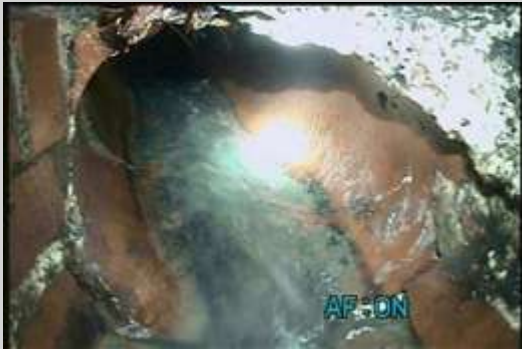
12 O'Clock Outflow

10 in. Circular Gravity Sewer  
Pipe Out @ 12 O'Clock

Invert Depth: **14.00** (ft.) Flow Characteristics: **Fast**

Deposits: ☒ None ☐ Mud ☐ Sludge ☐ Debris ☐ Grease

Infiltration: **None** Pipe Seal Cond: **Unknown**

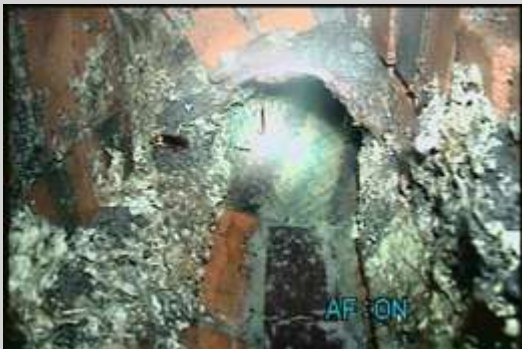
3 O'Clock Inflow

8 in. Circular Gravity Sewer  
Pipe In @ 3 O'Clock

Invert Depth: **13.88** (ft.) Flow Characteristics: **Fast**

Deposits: ☒ None ☐ Mud ☐ Sludge ☐ Debris ☐ Grease

Infiltration: **None** Pipe Seal Cond: **Unknown**

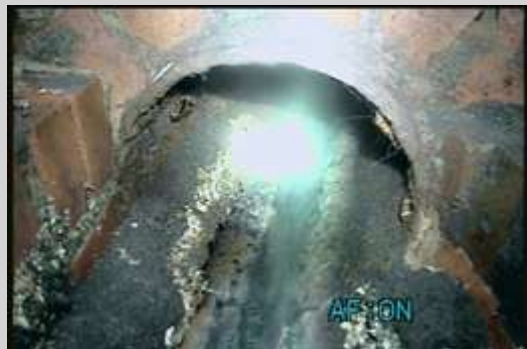
9 O'Clock Inflow

10 in. Circular Gravity Sewer  
Pipe In @ 9 O'Clock

Invert Depth: 13.80 (ft.) Flow Characteristics: Fast

Deposits: ☒ None ☐ Mud ☐ Sludge ☐ Debris ☐ Grease

Infiltration: None
